Lessons Learnt from Fires in Buildings

EUR 21006 EN

NEDIES PROJECT

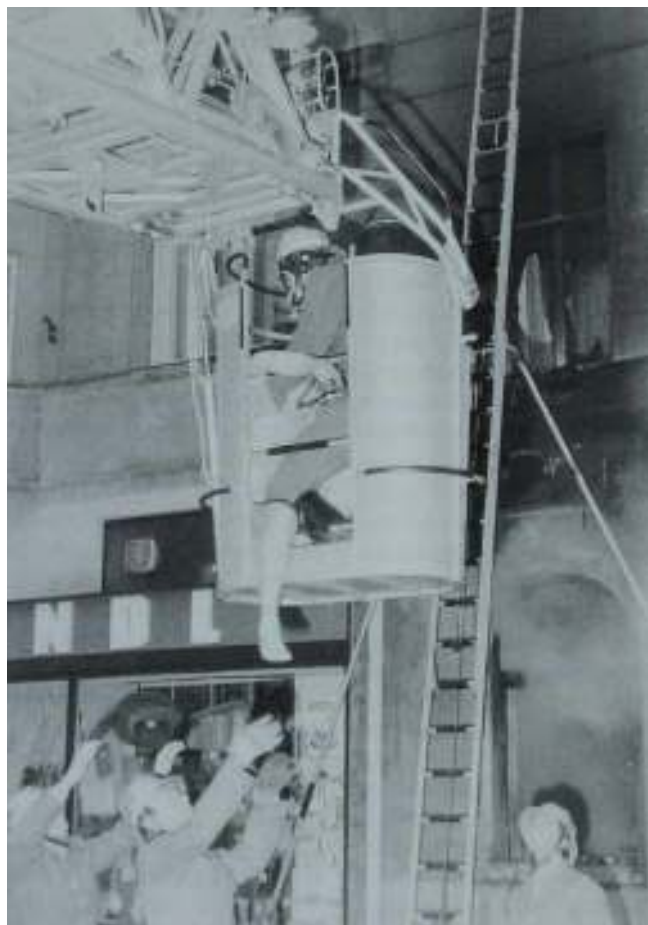
At 05.23 hrs the forces of the fire station "Leopoldstadt" arrived. The fire fighters immediately started rescue operations with ladders (14 m long) and the turntable ladders. As a consequence of the feedback of the commander a third fire station ("Favoriten" - command vehicle, 3 pumps and one turntable ladder), an additional turntable ladder and different special purpose vehicles. Using ladders and 5 turntable ladders the fire fighters rescued 35 guests. The fire fighters even succeeded in rescuing unconscious persons, sometimes not in a gentle but effective way (Fig. 2).

Figure 2. Rescue of an unconscious person using the turntable ladder

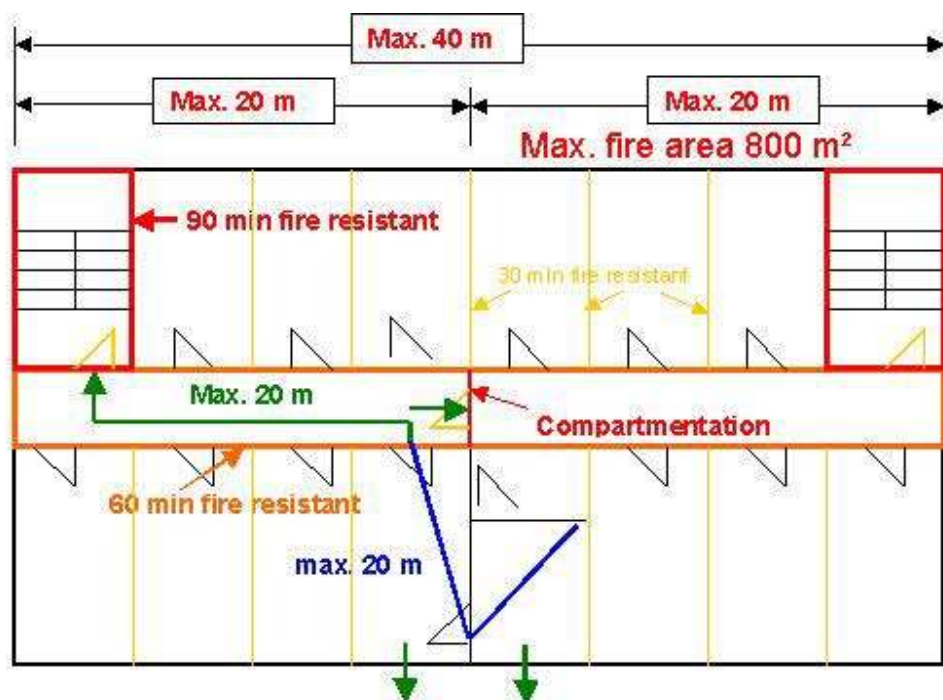
- Fire Resistance of separating walls /doors (See Fig. 6).
 - Staircase: walls 90 min, doors 30 min.
 - Walls between guestrooms and corridors: 60 min.
 - Walls between guestrooms: 30 min.

Figure 6. Scheme of compartmentation according to the technical guideline TRVB N 143

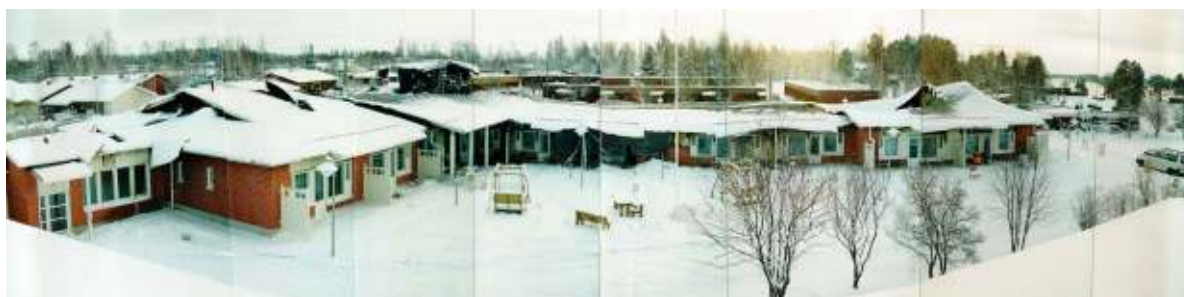
Figure 1. The senior citizens' service house seen from the north. The apartment where the fire broke out is located in the middle of the picture between the two garden swings

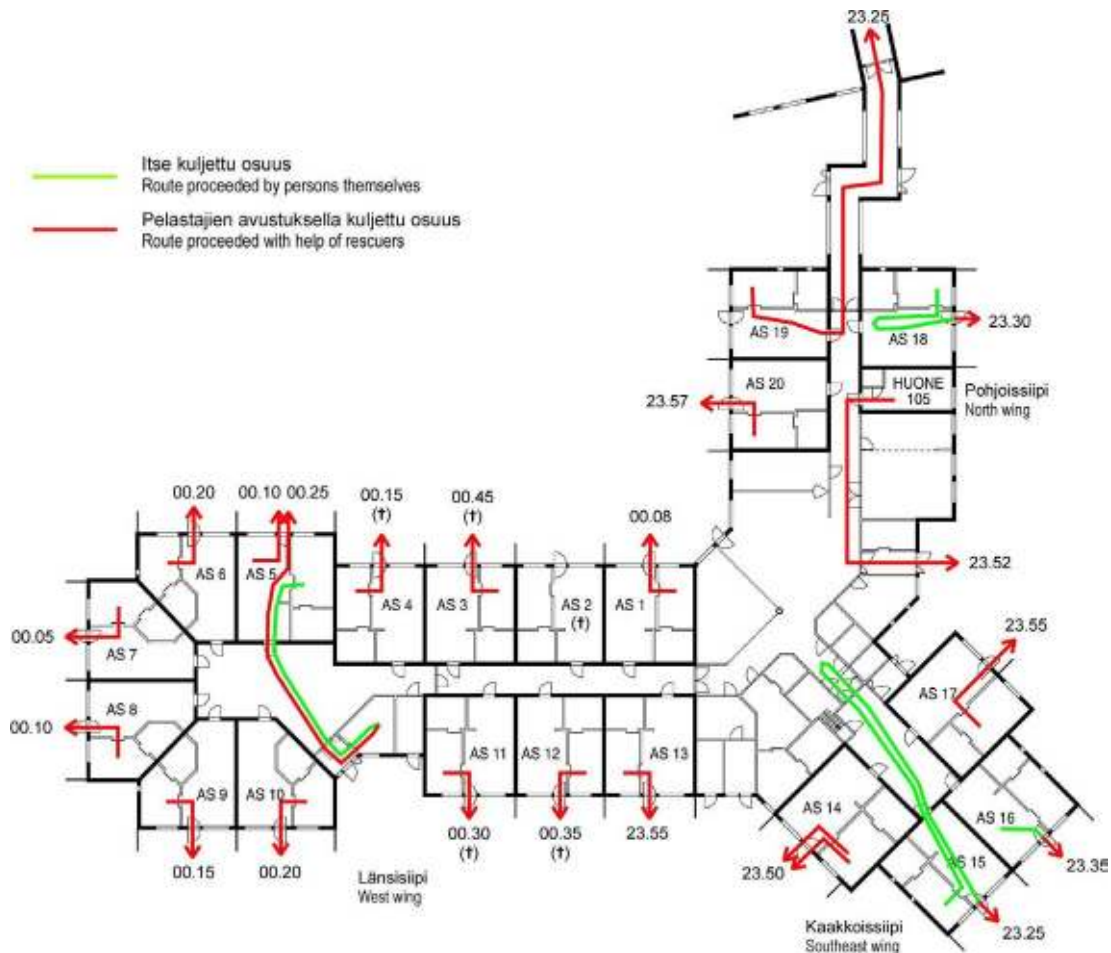
Only two of the occupants managed to leave the building without assistance. Others were rescued from their flats via the doors leading to the patio area. Several of the occupants were found in their beds and carried out (Fig. 5).

Figure 5. The time and routes by which the inhabitants were evacuated

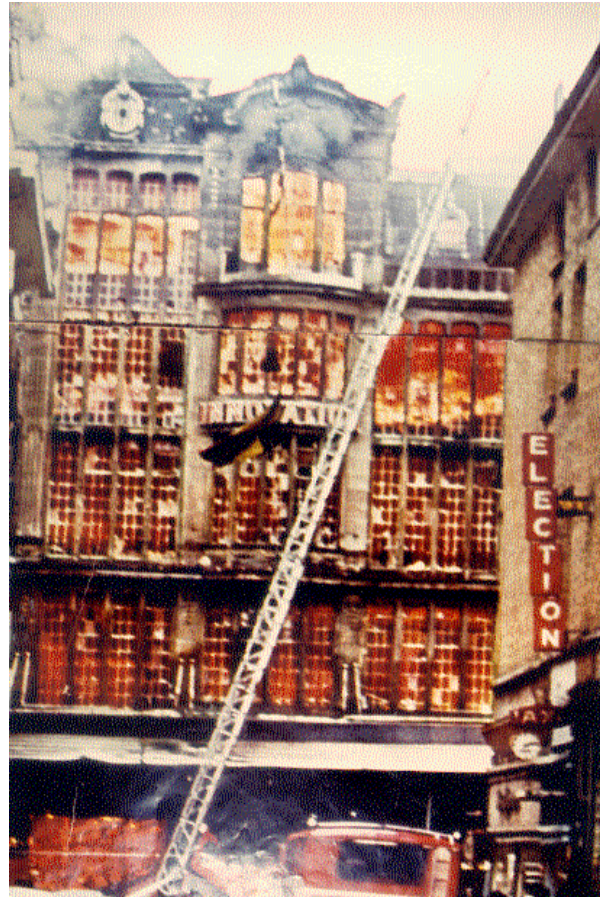
Figure 1. Main façade at the time of the fire

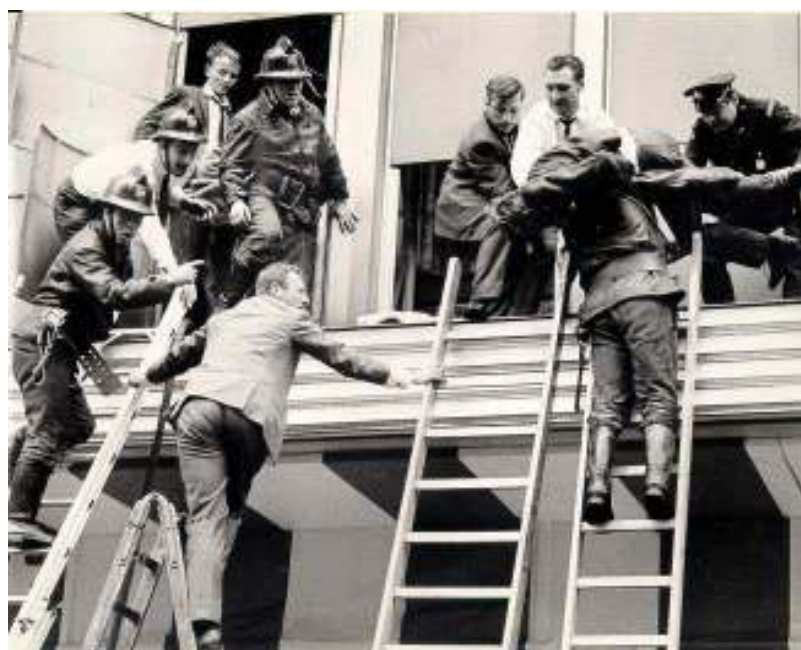
The fire engines arrived on the scene very quickly. They were immediately aware of the seriousness of the situation. Turntable ladders were requested instantly to support the fire-fighting operation. When they arrived on the scene, they immediately started rescuing people on the side facing Nieuwstraat (Fig.3). All available means and manpower were used for carrying out the rescue operations, including turntable ladders and straight extension ladders. The rescue operation was seriously hindered on the other sides of the building. The turntable ladders remained stuck in Nieuwstraat because of the heat. The ladders which were sent in support came too late for many of the people trapped in the building. The transport of the injured to the hospitals was rather chaotic. Initially there was an imminent danger that the fire would spread to other buildings, but that danger could soon be averted. Thanks to the build-up of means and manpower, the fire was under control fairly quickly (after 2 hours). It can be concluded from the reports and the eyewitnesses' statements that all the rescue and fire-fighting operations were conducted in a fairly efficient and orderly manner.

Figure 3. Rescue of people by emergency services

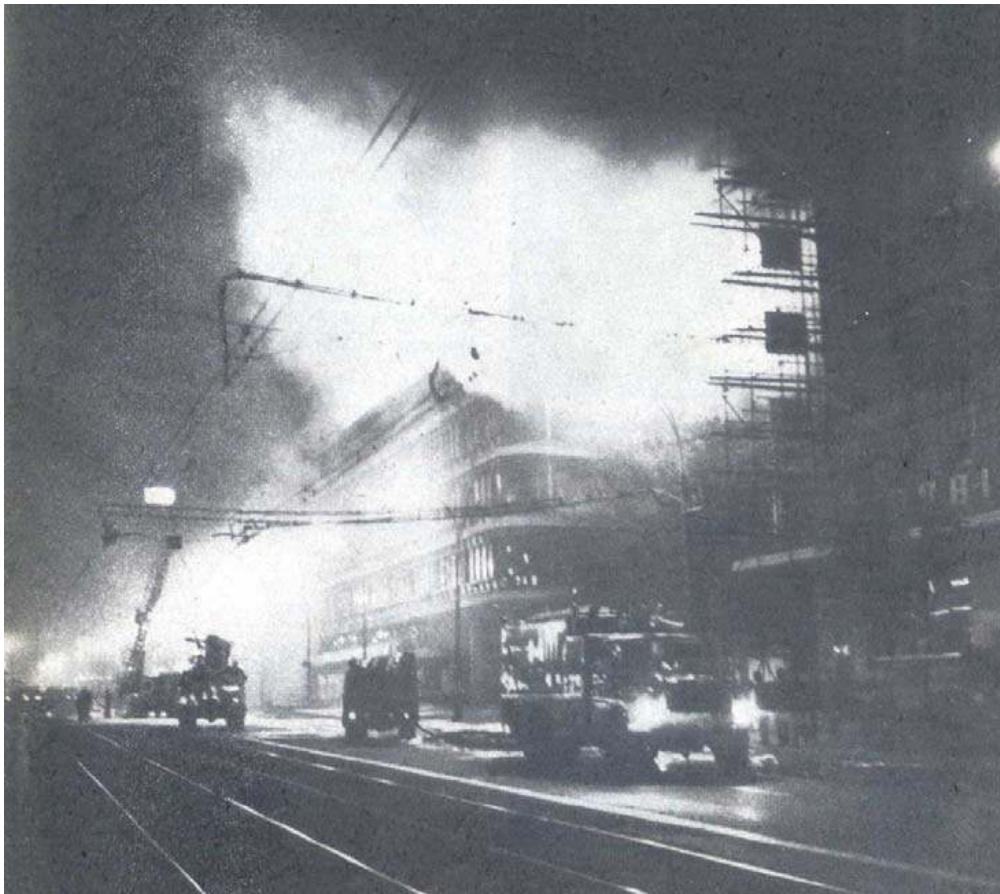
The cause of the fire was a failure of the not switched off mechanism of the escalator. Earlier recommendations after the fire inspection were not put into practice [5].

Figure 1. The fire in the Central Department Store was the biggest one in Warsaw after the Second World War

After the fire, the department store was restored in 1977 and equipped with modern sprinkler system with a special water reservoir, fire detection system and automatic smoke removal system.

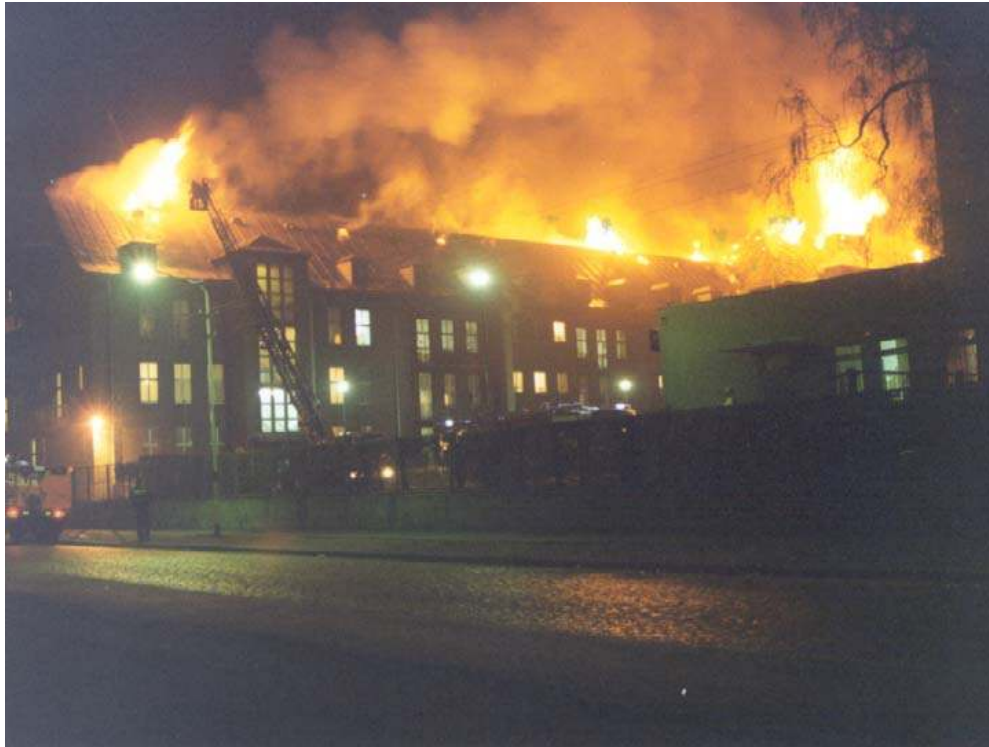
The fire was noticed at 03.20 hrs in the night in the central part of the main building. The wooden ceiling burned-through; the corridor was in smoke. After 40 minutes the area of the fire was 800 m². In the final phase, the area of fire reached 1,600 m² as a result of lack of access to the burned part of the loft (over the blind ceiling) (Fig. 2).

Figure 2. Night fire in Hospital in Szczecin

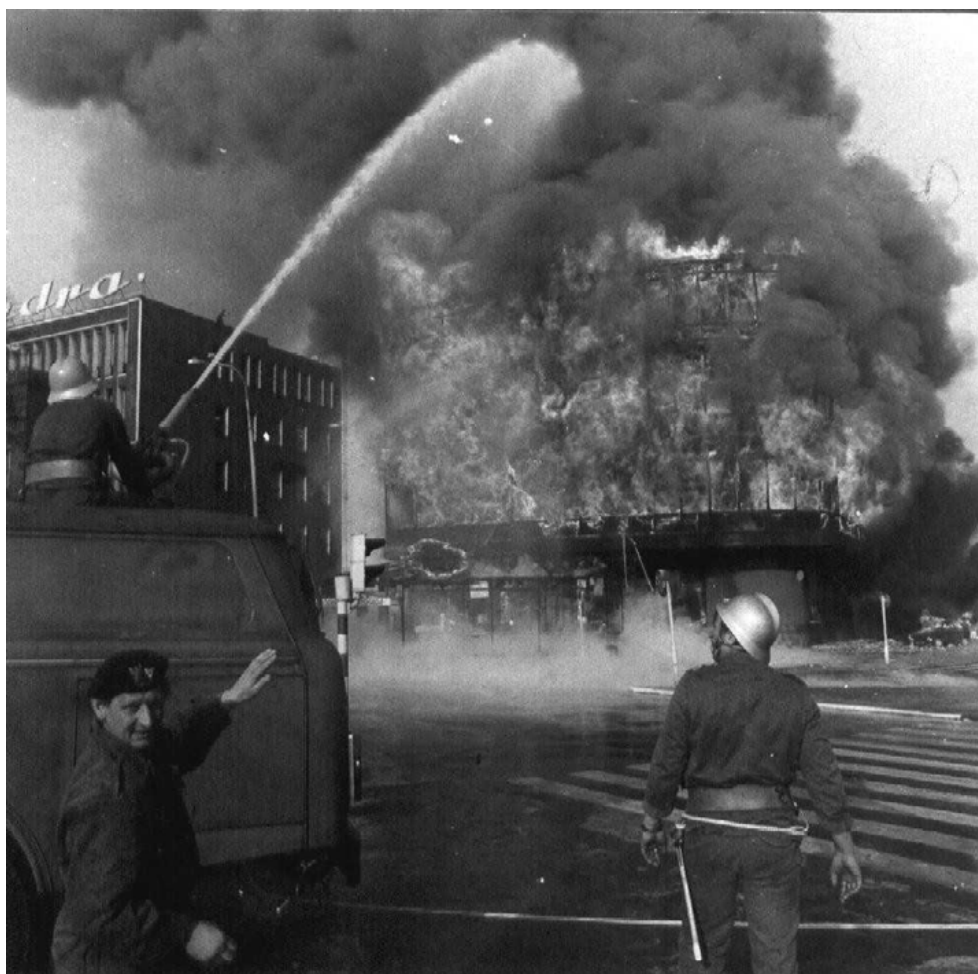
15 sections of the fire brigade took part in the rescue operation (100 firefighters). The cause of the fire was a short-circuit of electric wiring [4].

Figure 3. Fire in the Gastronomic complex "Kaskada" in Szczecin was the most tragic after the Second World War

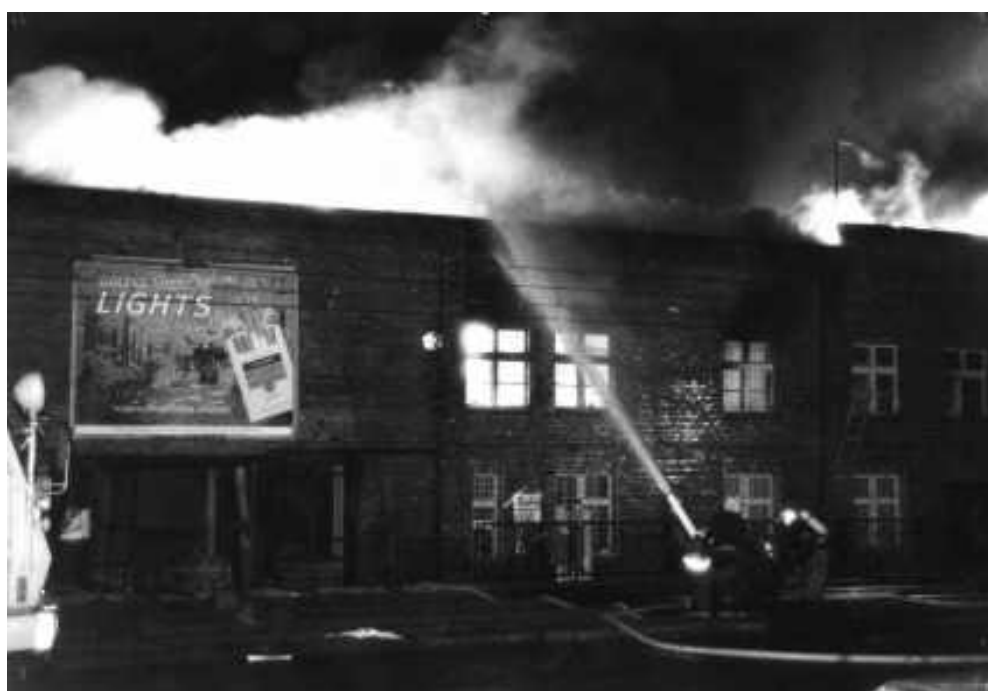
As a result of burns five persons died in hospitals. From over 200 injured, dozens experienced very serious body scalds (even 70%), faces, heads and hands. Many of them did not recover till the present day. The cause of the fire was arson [3],[9].

Figure 4. Fire in The show hall in Gdańsk Shipyard was one of the biggest ones after the Second World War

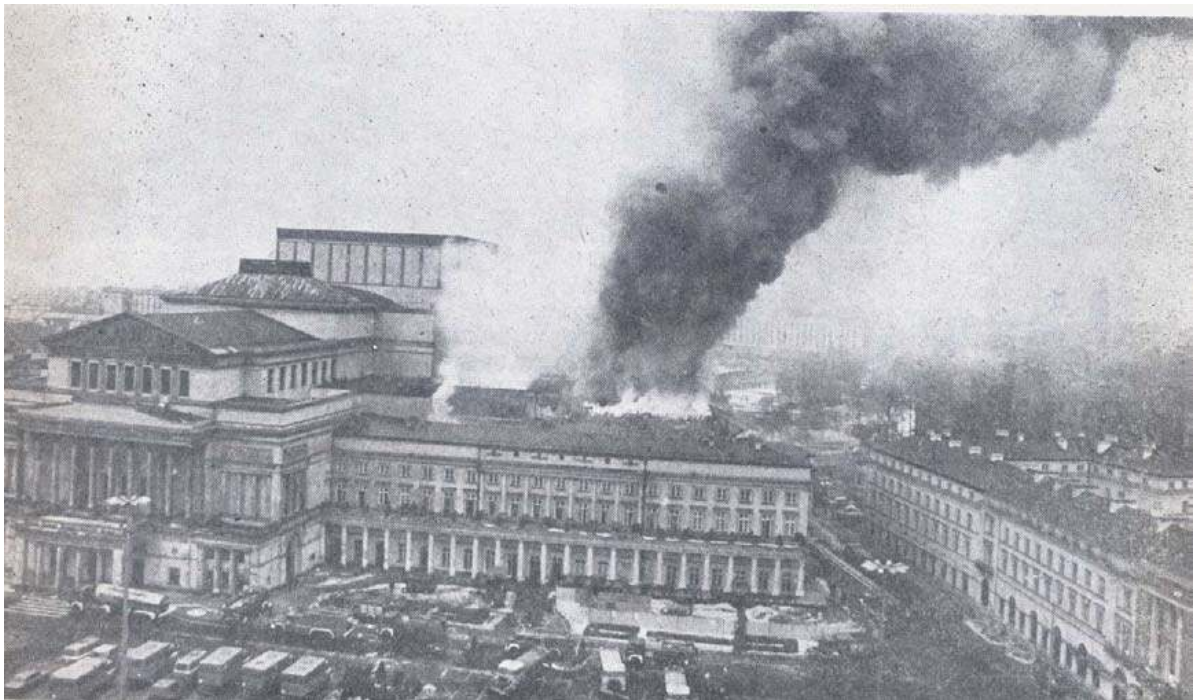
The fire was put out at about 22.30 hrs. Cubature of the fire was about 25,000 m³. In the fire there were burnt: the revolving scene with equipment, two balconies of the auditorium, the wardrobe, the roof over the auditorium (surface of about 400 m²), stage decorations in store rooms and the lighting and acoustic devices in the auditorium. The cause of the fire was probably arson. Earlier recommendations after the fire inspection were not put into effect [8],[11].

Figure 5. Fire in the National Theatre in Warsaw

Restoration was finished in 1994. The building was equipped with modern sprinkler system with a special water reservoir, fire detection system and automatic smoke removal system.

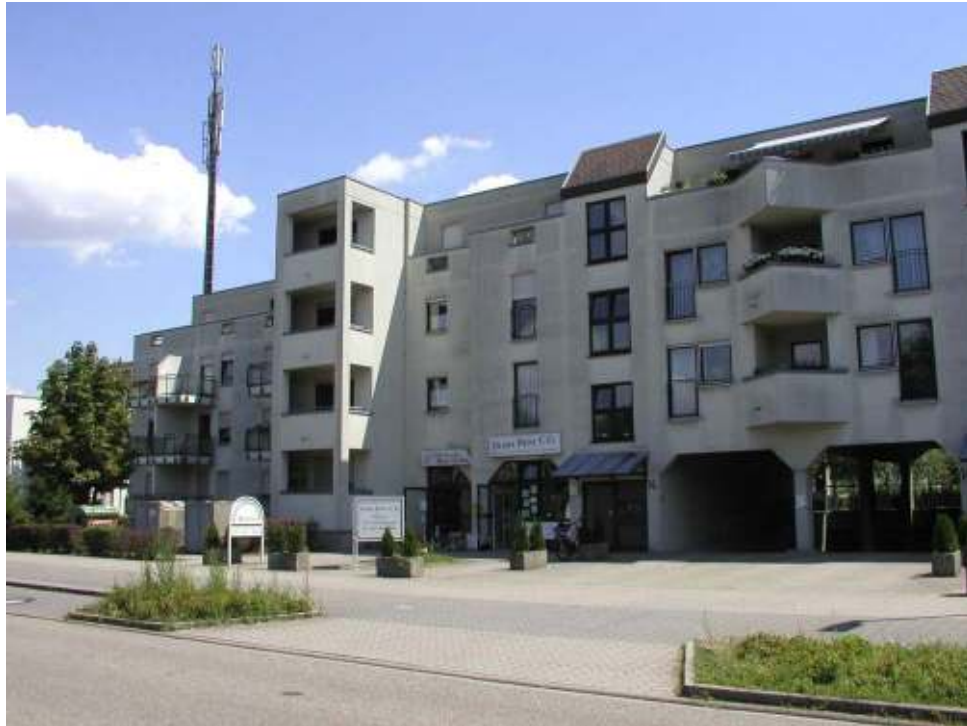
A fire started in a penthouse apartment in a four-storey dwelling house at around 14.00 hrs (Fig. 6). The apartment has a living room with open kitchen, a separated bedroom and bath. The access to the apartment is ensured over a inner stairway. This stairway is terminated by smoke control doors to the corridors. There is a fume extraction cupola at the highest point of the stairway.

Figure 6. The location – street view. The access to the entrance is located at the left side of the building. There is a footpath which leads to the entrance at the rear side

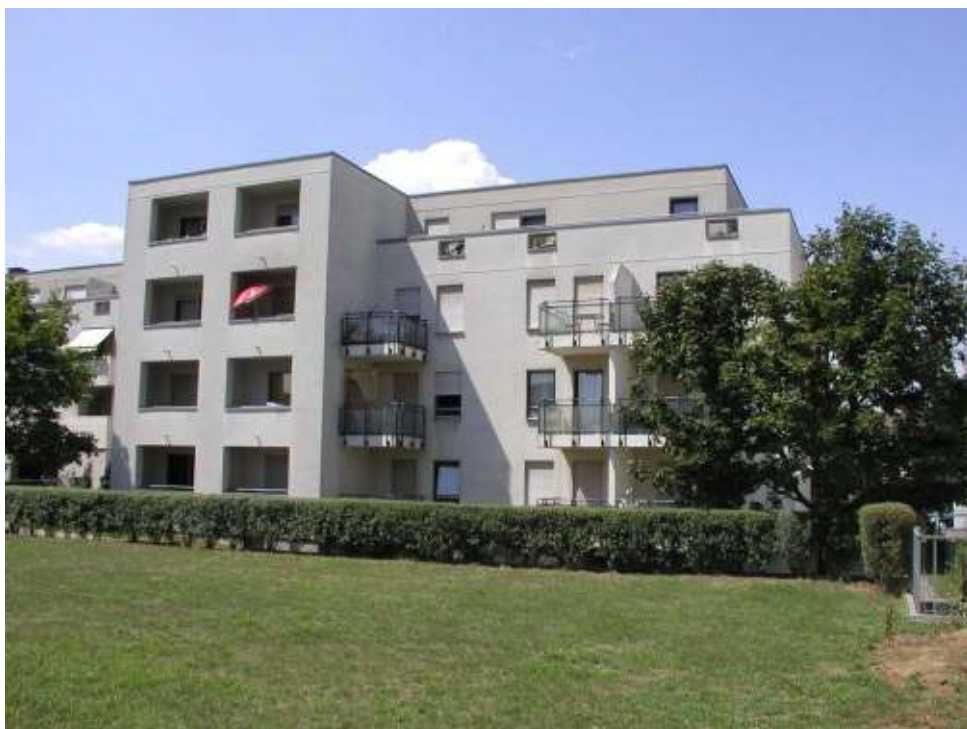
With this information (the failed fume extraction cupola in a inner stairway and no expected hazard to persons), the commander decided an attack with a portable ladder from outside. He stopped the attack at the stairways and sent a second troop with BA and a branch pipe to the roof terrace (Fig. 7). The first troop stood stand-by with his full equipment in front of the door in the inner corridor.

Figure 7. View from the rear side. The penthouse is visible at the right

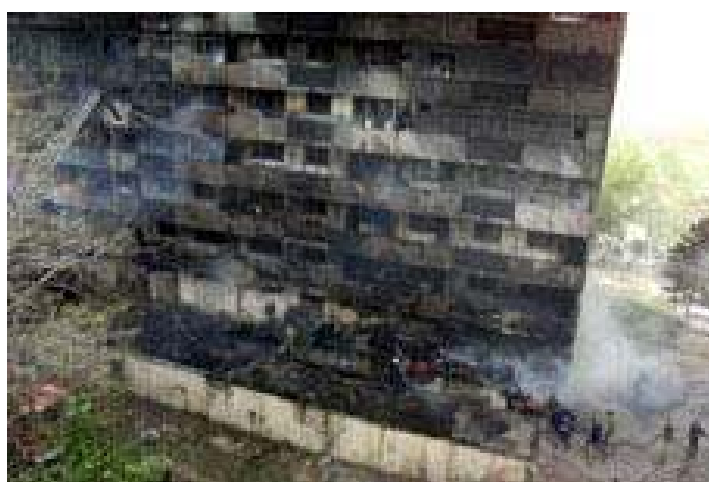
A devastating fire burst out few minutes before noon of the penultimate Sunday of April 2002, in a 10-storey apartment block at the Drumul Taberei area in Bucharest capital (see Fig. 1). The fire destroyed integrally 32 apartments on two staircases and other 45 were partially damaged in just few tenths of minutes, leaving on street 160 people, of which just one apartment was insured. The fire was ignited from a warehouse of the textile firm “Multi Core Trading S.A”, having as shareholders five citizens from Cyprus, located at the basement of the block. The military fire fighters arrived at the disaster scene with 9 fire-fighters tankers and extinguished the fire on the block after one hour and a half. Because of the strong wind, the fire was extended with high rapidity on the front of the block, severely affecting the apartments of the first four storeys and breaking the windows of the remaining ones up to the tenth storey.

Figure 1. The operative action of the fire-fighters at the affected façade of the 10-storey block

As a result of the fire five persons were intoxicated, being interned at the hospital requesting medical assistance. Also the fire seized two minivans parked in the front of the block, which exploded causing panic in the neighbourhood. The building specialists arrived afterwards at the fire scene affirmed that the resistance structure of the block was unaffected, but the entire façade needed to be fully repaired.

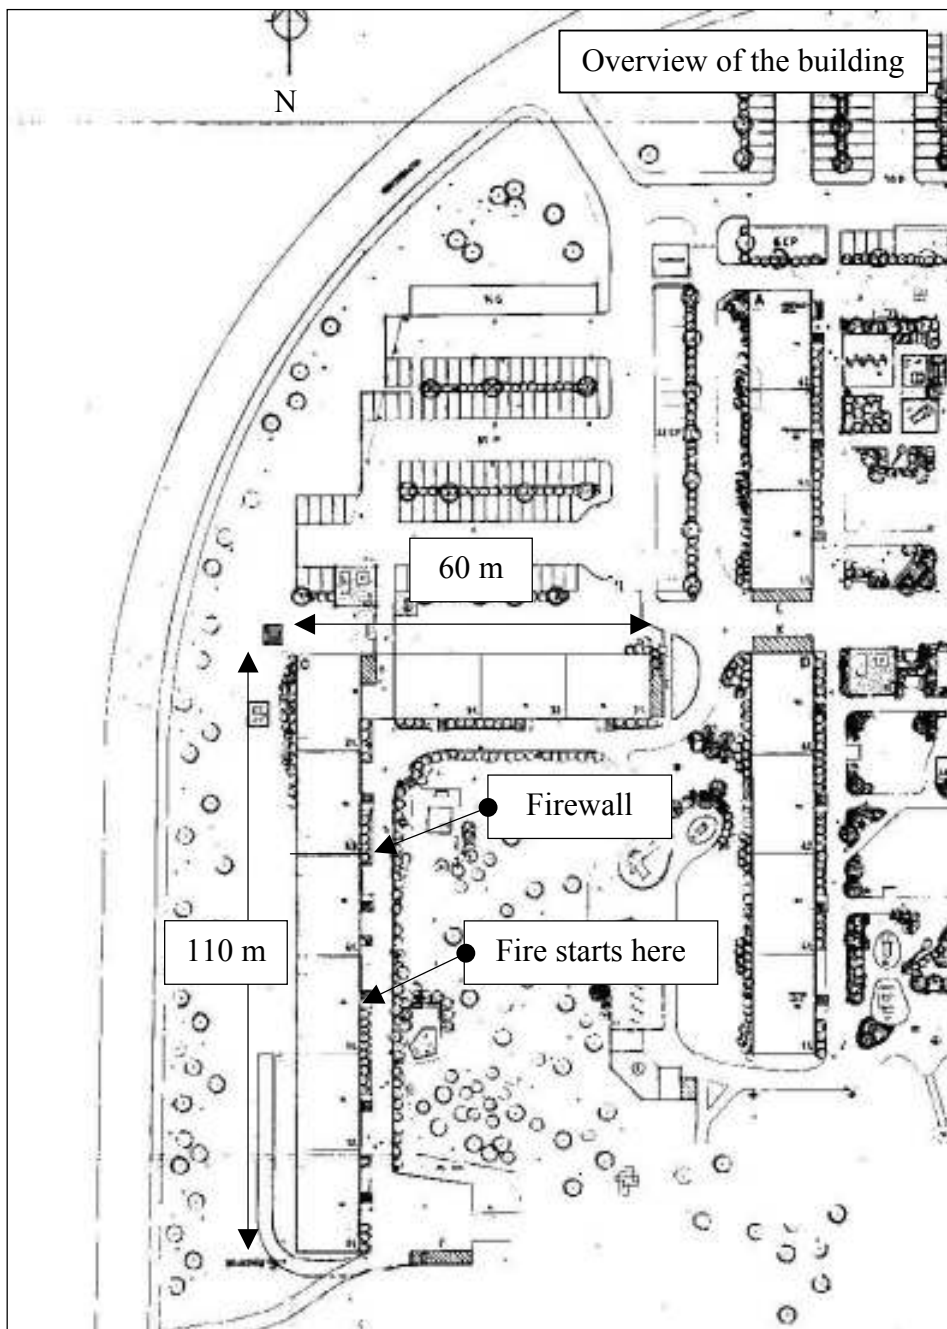
As the crews were getting close to the address they were notified through dispatch that there might be people still in the apartment concerned, and that it most likely was an apartment fire. As they turned the corner of the building, they saw a live fire with flames filling one apartment's windows (Fig. 2) on the top (4th) floor. The senior officer ordered a typical inside attack according to a SOP (standard operating procedure), with the intent of gaining access to the apartment and if possible save the person/s still inside.

Figure 2. Outline of the building

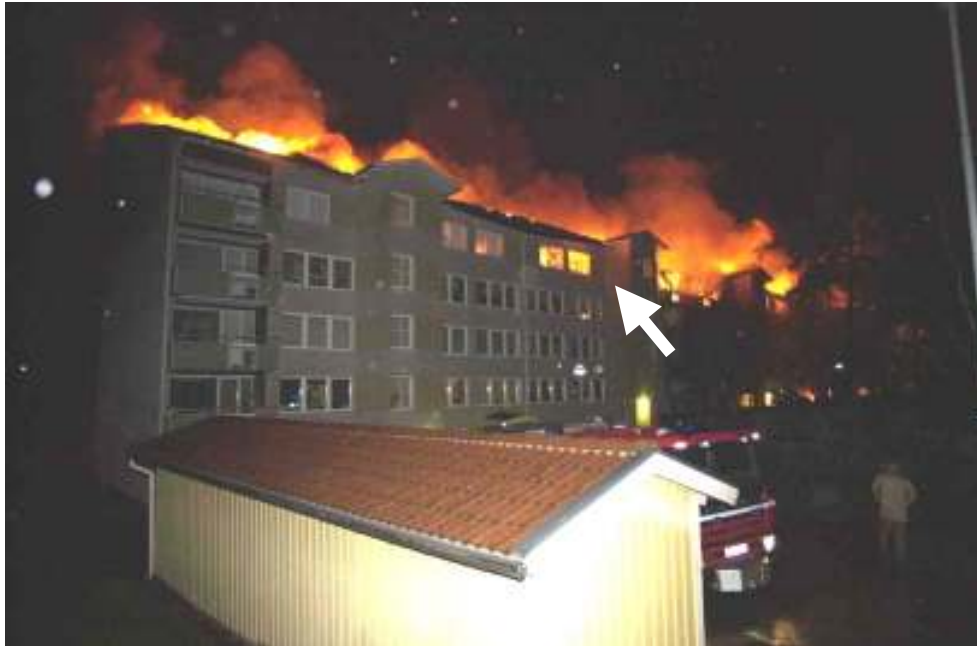
During the following 45 minutes the fire spread throughout the length of the entire attic, which was about 160 m long with a total area of about 1900 m² (see Fig. 3 and 4). In the same period of time, the fire spread to all 25 apartments on the 4th floor, totally burning them out. The attic had a firewall rated to withstand 60 minutes of fire (see Fig. 2). This was not known during the fire and none observed any delay in the fire spread that hinted of its existence

Figure 3. The building seen from SW, about 35 minutes after arrival. Fire started at the arrow

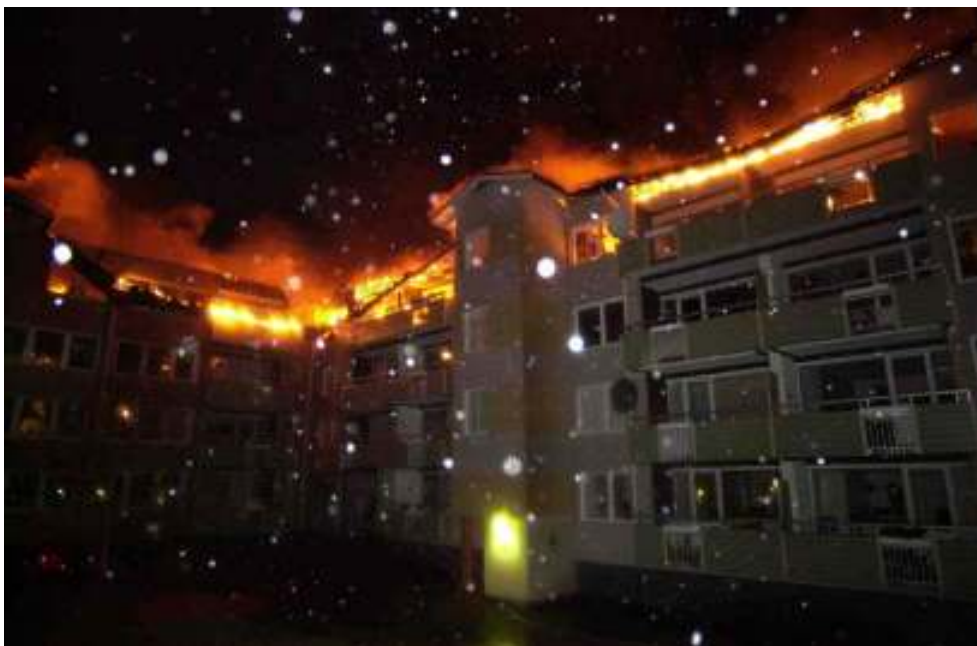
Figure 4. Fire spreads around the NW corner about 40 minutes after arrival

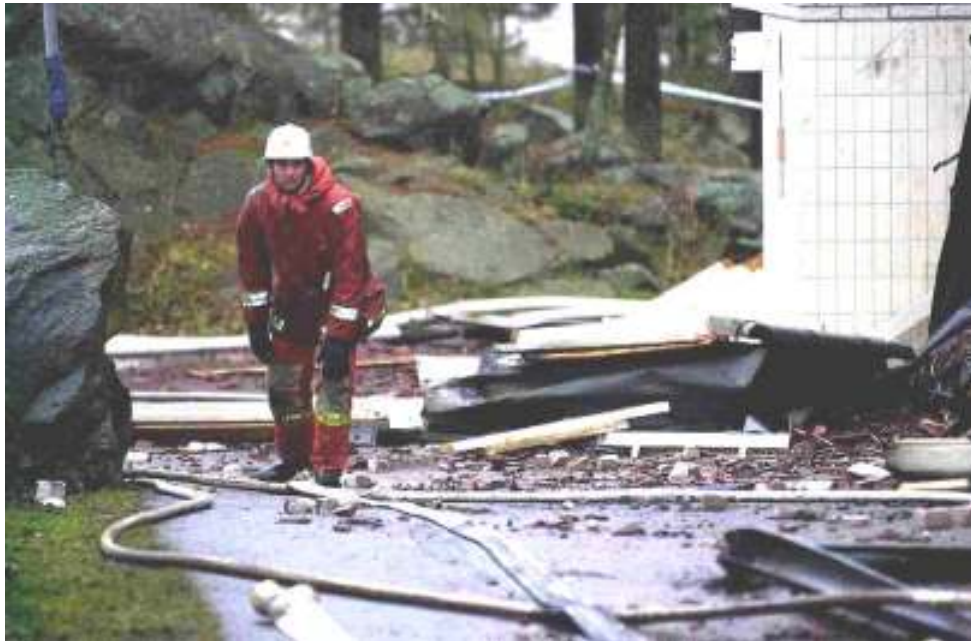
It was decided at that time that all apartments should be searched and evacuated, due to the recurring collapses of the outside wall in front of the building. During the evacuation of more than 90 persons, the fire fighters had to constantly evade large portions of the roof and brick falling from the top floor (Fig. 6).

Figure 6. The space in front of the building (note fire-hose under debris)

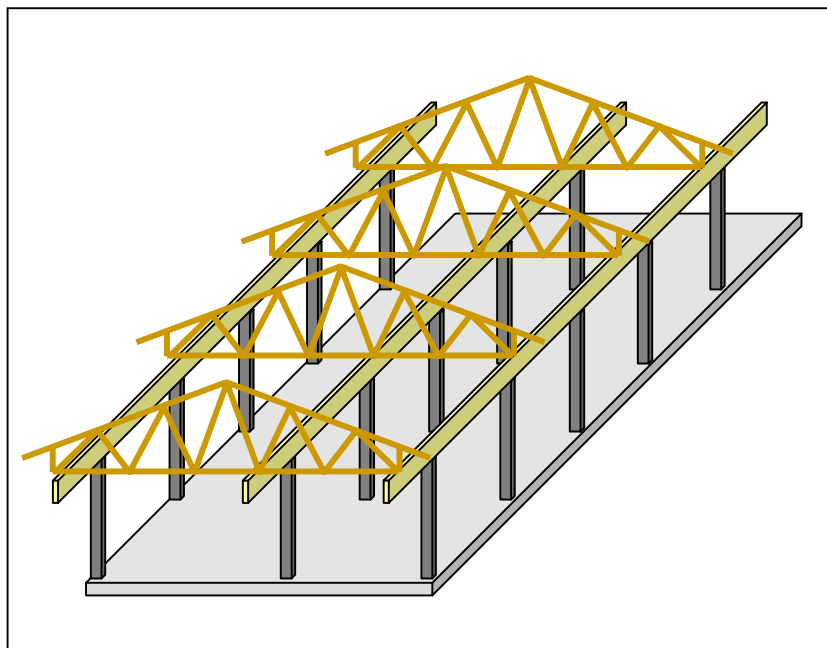
The older part of the house did not have excess load-bearing capacity enough to allow for the 4th floor to be designed in the same way as the three others. It was therefore decided that the 4th floor should have a lighter construction with steel pillars and glulam beams (laminated timber) carrying a traditional wooden truss roof (see Fig. 7).

Figure 7. The 4th floor construction of steel pillars, glulam beams and wooden trusses

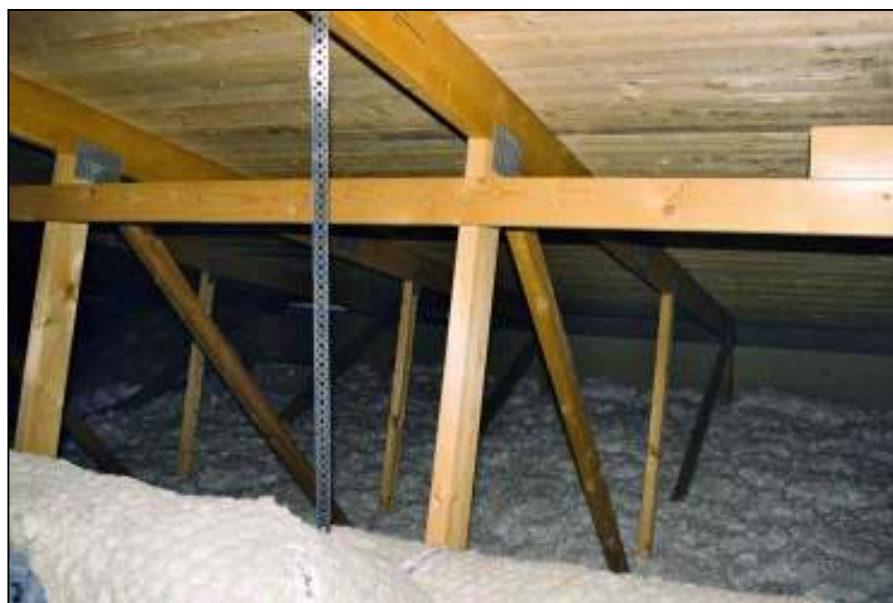
All fire-rated parts of the 4th floor construction was either anchored in or held up by the unprotected and unrated truss-roof (Fig. 9). As the trusses burned through and collapsed, the fire rated constructions failed in rapid succession. When they fell into the apartments they also damaged the apartment walls, allowing for horizontal fire spread (Fig. 10a-c).

Figure 9. The inside of the attic (neighbouring house) with trusses and insulation
